**Flood Control Project Maintenance
Levee Inspections****LMA District Cover Sheet****Spring 2015 Levee Inspection Results****Reclamation District No. 2107 Mossdale Island**

Levee Inspection Report By Mile - Spring 2015

Reclamation District No. 2107 Mossdale Island

Waterway	Bank	Unit Miles	Inspection Start/End	Inspector
Unit No. 01 San Joaquin River	Left	2.33	05/06/2015 05/06/2015	Maksim Khashchuk

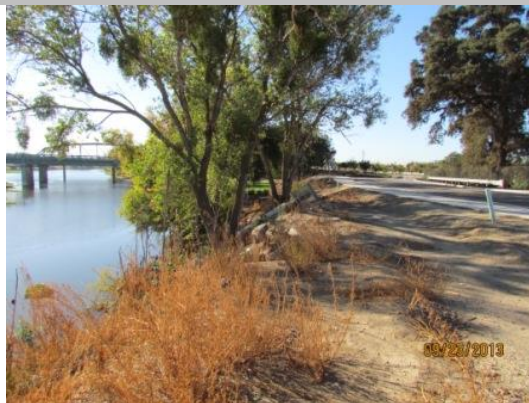
Photo 1 of 1 : SP_2015_RD2107_329_1_20150317_00001.jpg

LM Start	0.03	Rating **	N	Issue No.	1
LM End	0.03	Issue Type +	Ma	Location *	WS
Category	Earthen Levee			GPS Latitude/Longitude	
				Start	End
Item	Trim / Thin Trees			37.786993 °	37.786993 °
				-121.308694 °	-121.308694 °
DWR ID	DWR_RD2107_01_s_2012_1				
Action/Comments					
Tree stumps.

Photo of waterside slope. Stumps present from prior tree removal for access and visibility.

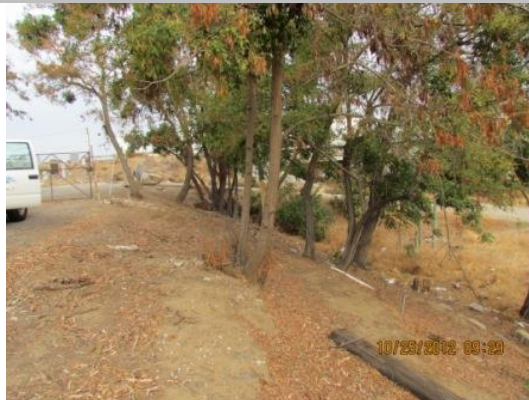
Photo 1 of 1 : SP_2015_RD2107_329_2_20150317_00002.jpg

LM Start	0.26	Rating **	N	Issue No.	2	
LM End	0.26	Issue Type +	Ma	Location *	WS	
Category	Earthen Levee			GPS Latitude/Longitude		
				Start	End	
Item	Trim / Thin Trees			37.784316 °	37.784316 °	
				-121.306498 °	-121.306498 °	
DWR ID	DWR_RD2107_01_s_2012_2					
Action/Comments						
Tree stumps.

Tree stumps present on slope. They were left from prior vegetation removal for access and visibility.

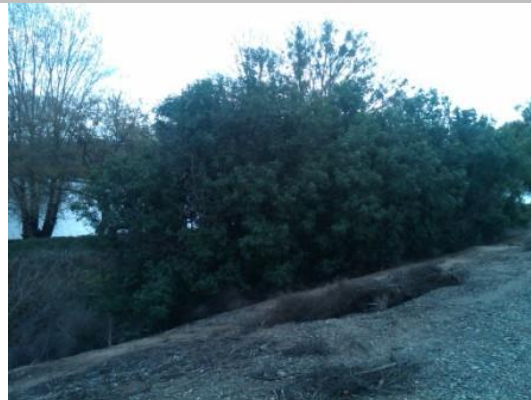
Photo 1 of 1 : SP_2015_RD2107_329_54_20150317_00005.jpg

LM Start	0.41	Rating **	M	Issue No.	54
LM End	0.41	Issue Type +	Ma	Location *	WS
Category	Earthen Levee			GPS Latitude/Longitude	
				Start	End
Item	Vegetation			37.782737 °	37.782737 °
				-121.304426 °	-121.304426 °
DWR ID	DWR_RD2107_01_s_2012_54				
Action/Comments					
Elderberries are blocking visibility and flood fight capability. Inspector Comments: Large elderberry on water side slope.

03/26/2012 Large elderberry located on water side slope.

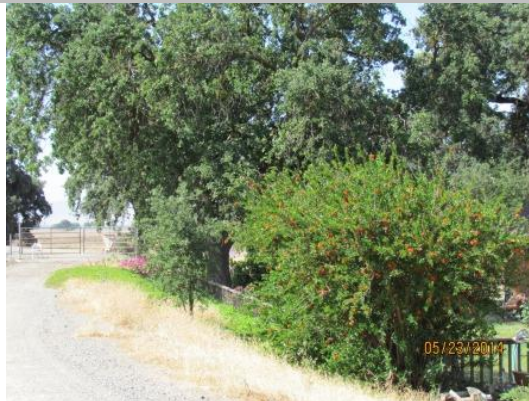
Photo 1 of 1 : SP_2015_RD2107_329_17_20150317_00004.jpg

LM Start	1.23	Rating **	M	Issue No.	17
LM End	1.23	Issue Type +	En	Location *	LS
Category	Earthen Levee			GPS Latitude/Longitude	
				Start	End
Item	Vegetation			37.774123 °	37.774123 °
				-121.307189 °	-121.307189 °
DWR ID	DWR_RD2107_01_s _ 2012_17				
Action/Comments					
Landscaping					
Inspector Comments: Landscaping and fence present on levee slope.

View of landscape planting on landside levee slope and a 3-ft yard fence at the levee toe.

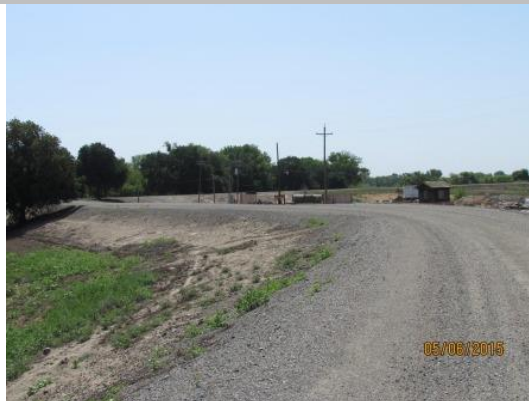
Photo 1 of 1 : SP_2015_RD2107_329_19_20150511_00011.jpg

LM Start	1.34	Rating **	A	Issue No.	19
LM End	1.34	Issue Type +	Ma	Location *	WS
Category	Earthen Levee			GPS Latitude/Longitude	
				Start	End
Item	Vegetation			37.772616 °	37.772616 °
				-121.306718 °	-121.306718 °
DWR ID	DWR_RD2107_01_s _ 2015_19				
Action/Comments					
Control annual grass and weeds on the levee slopes and easements.

View of the acceptable vegetation control on the landside levee slope.

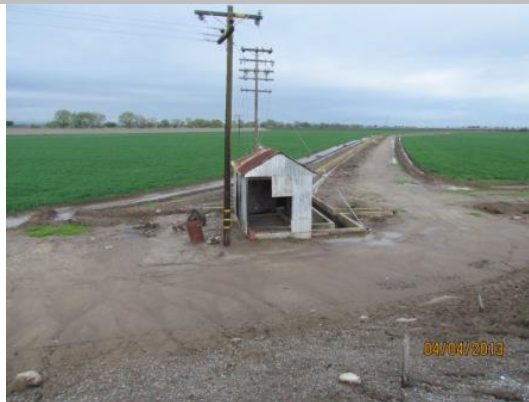
Photo 1 of 1 : SP_2015_RD2107_329_11_20150317_00003.jpg

LM Start	2.19	Rating **	A/W	Issue No.	11
LM End	2.19	Issue Type +	Ma	Location *	CR
Category	Earthen Levee			GPS Latitude/Longitude	
				Start	End
Item	Encroachments			37.762868 °	37.762868 °
				-121.309708 °	-121.309708 °
DWR ID	DWR_RD2107_01_s_2012_11				
Action/Comments					
Pipe					
Inspector Comments: Irrigation intake pipe through levee freeboard.

View of the pipe location; alignment through levee.

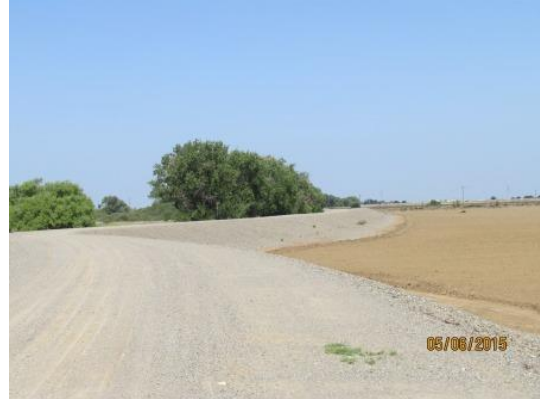
Photo 1 of 1 : SP_2015_RD2107_330_8_20150511_00005.jpg

LM Start	0.14	Rating **	A	Issue No.	8
LM End	0.14	Issue Type +	Ma	Location *	LS
Category	Earthen Levee			GPS Latitude/Longitude	
				Start	End
Item	Vegetation			37.761487 °	37.761487 °
				-121.311772 °	-121.311772 °
DWR ID	DWR_RD2107_02_s_2015_8				
Action/Comments					
Control annual grass and weeds on the levee slopes and easements.

View of the acceptable vegetation control on the landside levee slope.

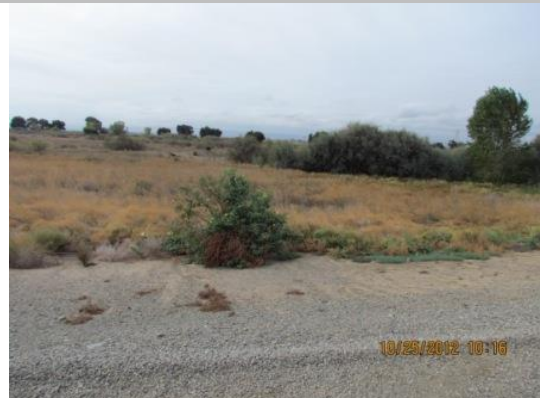
Photo 1 of 1 : SP_2015_RD2107_330_4_20150317_00001.jpg

LM Start	0.51	Rating **	M	Issue No.	4
LM End	0.51	Issue Type +	Ma	Location *	WS
Category	Earthen Levee			GPS Latitude/Longitude	
				Start	End
Item	Vegetation			37.764780 °	37.764780 °
				-121.316717 °	-121.316717 °
DWR ID	DWR_RD2107_02_s_2012_4				
Action/Comments					
Elderberries are blocking visibility and flood fight capability. Inspector Comments: Elderberry bush on waterside.

Elderberry located on waterside slope.
